Bevel Gear Shaft Repair

By Mr. Zooks @ [The GS Resources Forum](#)

Mr. Zooks was kind enough to snap some pictures and type up his procedure illustrating how he repaired a broken bolt holding the U-joint between the gearbox and axle. Thank you Mr. Zooks! -BassCliff

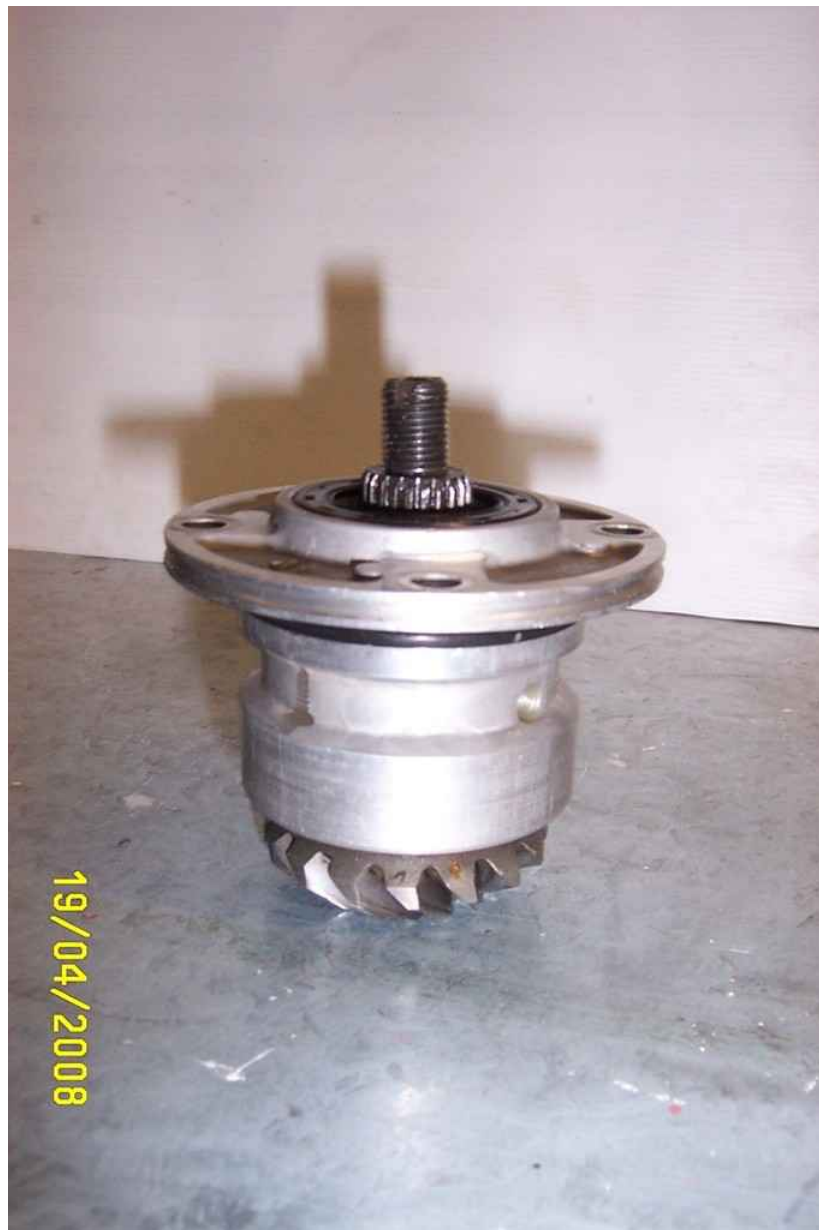
This is what the bevel gear from the back of the gearbox should look like.

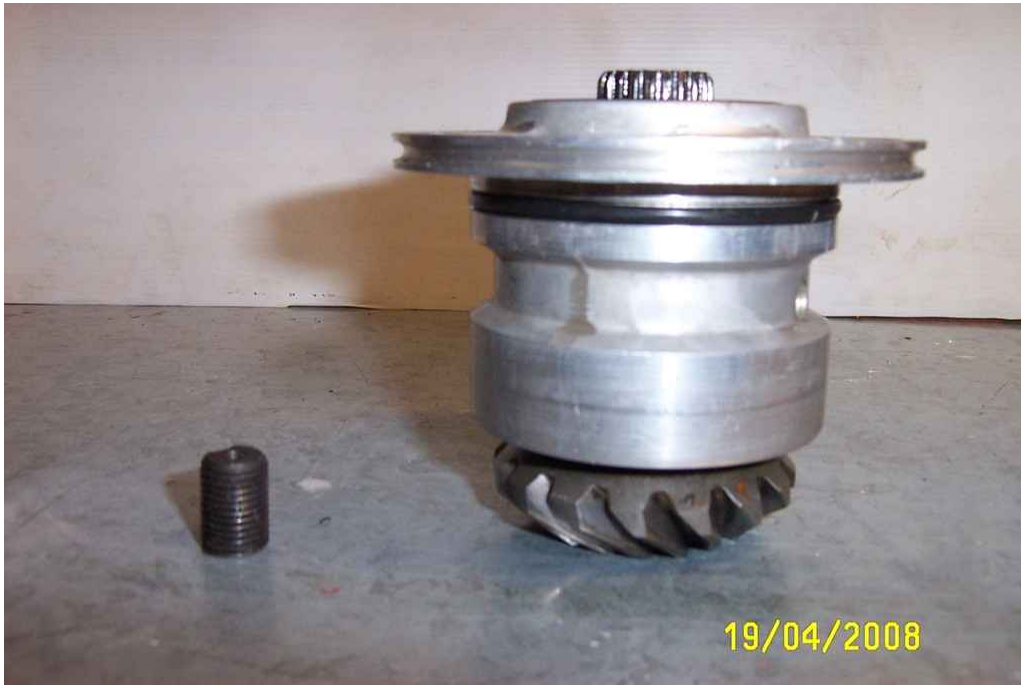
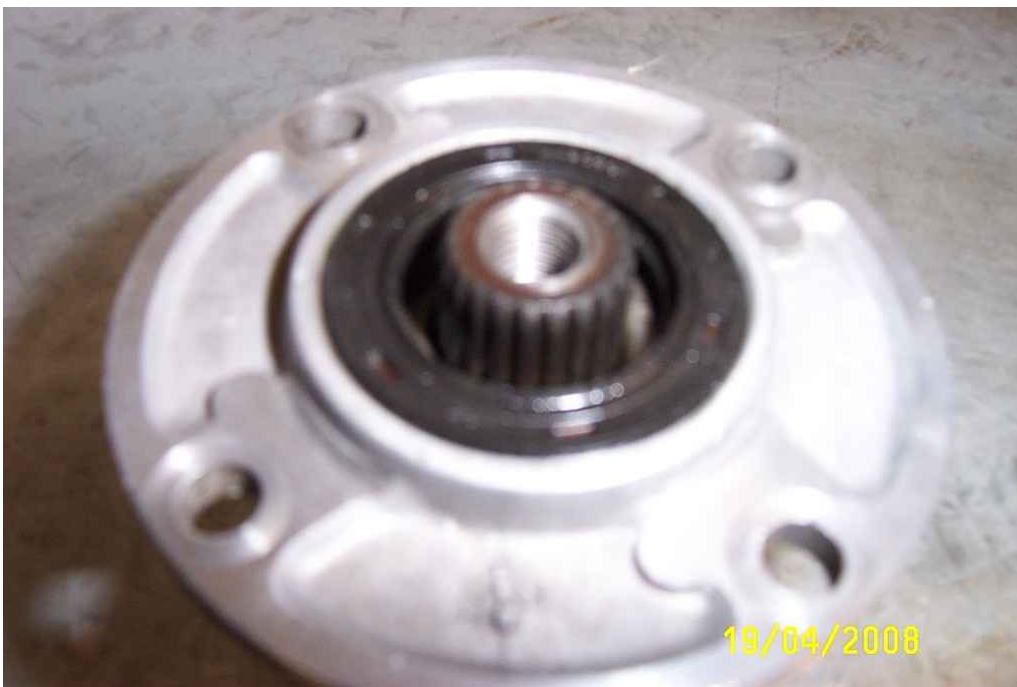
Unfortunately this is all too common on these bikes. The nut comes off the thread and then the thread snaps off due to movement.

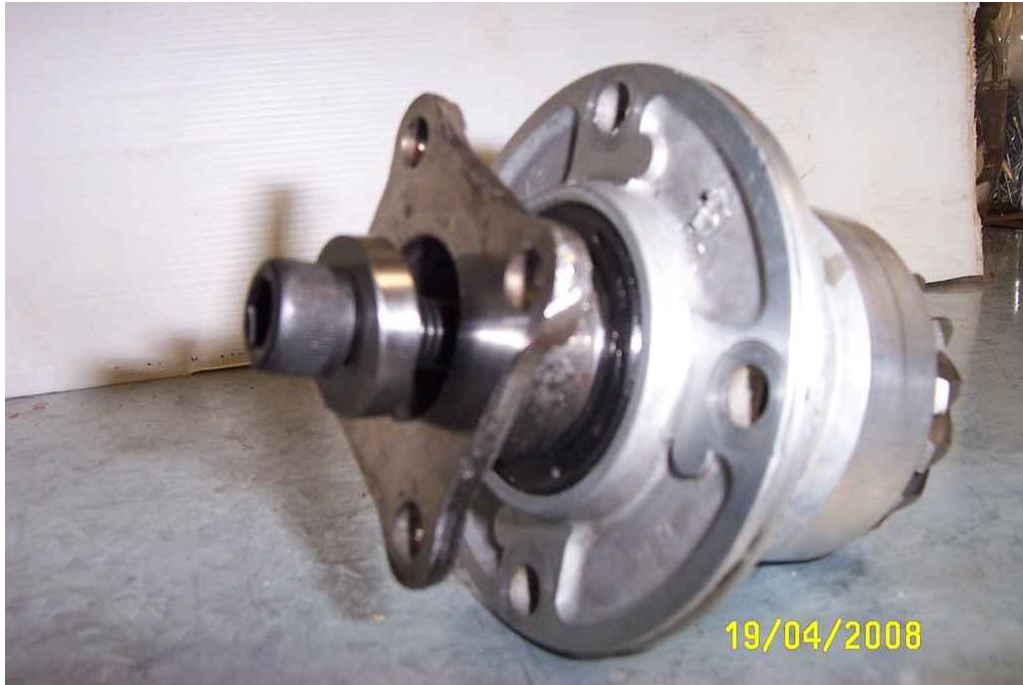
This shows the half of the universal joint that the bolt is designed to hold in place.
